# Manhole Inspection Summary

Manhole # S31UU\_003MH

**Location** Address: **3001 30TH ST**

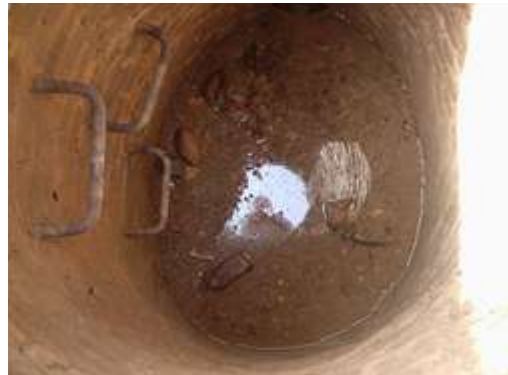
Top View

☒ **Debris** (not Condition related)

Channel debris.

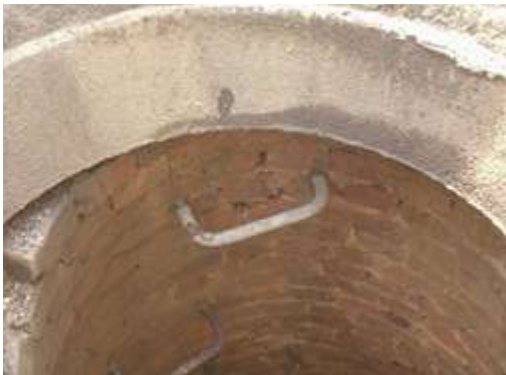
Defect

☒ **Leaks**

Condition: ☐ Sound ☐ Cracked ☐ Root Intrusion ☐ Loose Brick ☒ **Deteriorated**

Infiltration: ☐ None ☒ **Joint** ☐ Cracks ☐ Mortar ☐ Roots ☐ Wall

Frame leaks. Adjustment deterioration, loose brick and infiltration - other side.

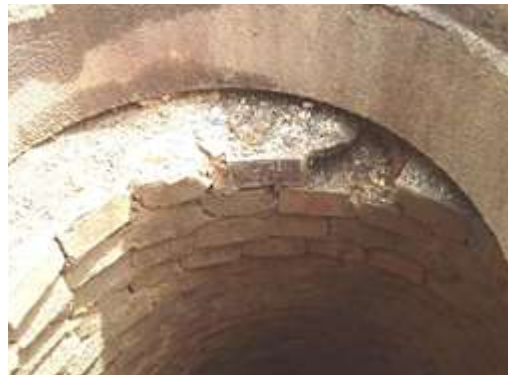
Defect

Frame leaks. Adjustment deterioration, loose brick and infiltration.

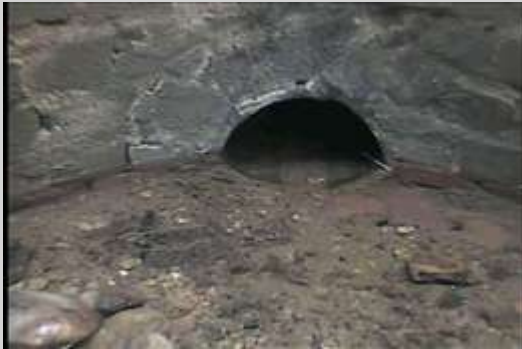
8 in. Circular Gravity Sewer  
Pipe Out @ 12 O'Clock

Deposits: ☐ None ☒ **Mud** ☐ Sludge ☒ **Debris** ☐ Grease

Silt Depth: **2** (in.) Deposits Extent: **Light**
